THE WALL

THE WINDOW

Te Deum Window Update

STAINED GLASS WINDOW CONDITION ANALYSIS: *Te Deum* Window by Tiffany Studios Westminster Presbyterian Church Dayton, OH

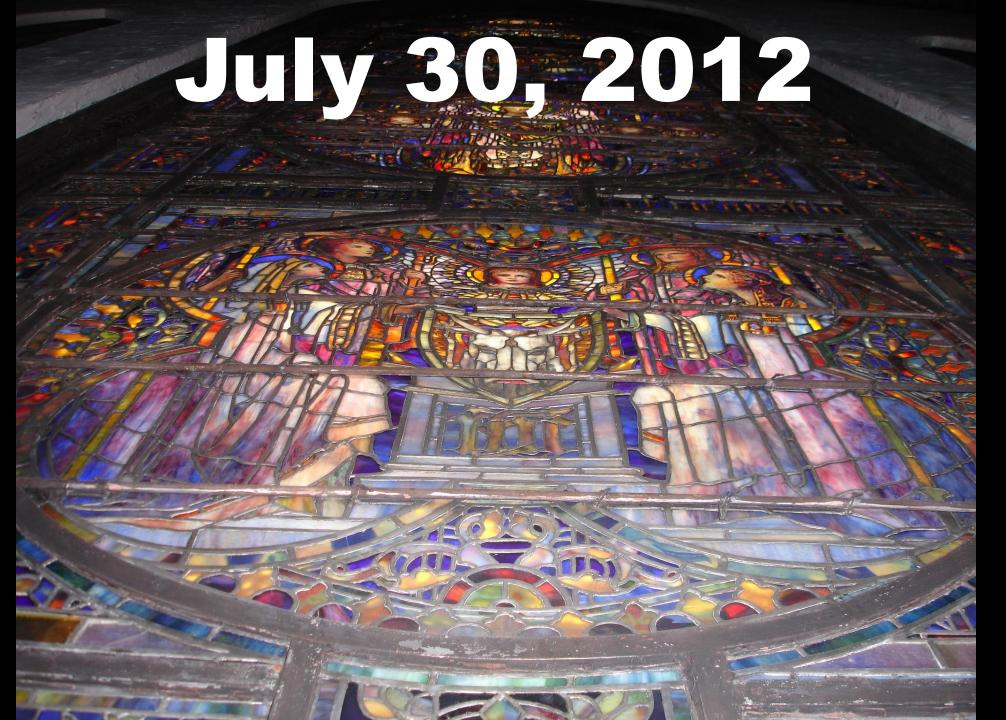
There was a week of 90+ degree days. This is when we first noticed the window had shifted its shape.

See how it bows

Invited back, Mr. Venturella agrees the window has gotten worse since his visit 13 years earlier. Without delay, it needs to be restored. The entire window needs to be taken out. His studio is equipped to do the highest quality repairs. He will work up a formal estimate for us.

We should plan on the window being out for at least 9 months. A visual replacement can be created on fabric and hung in its place. The projected cost is upwards to \$300,000.

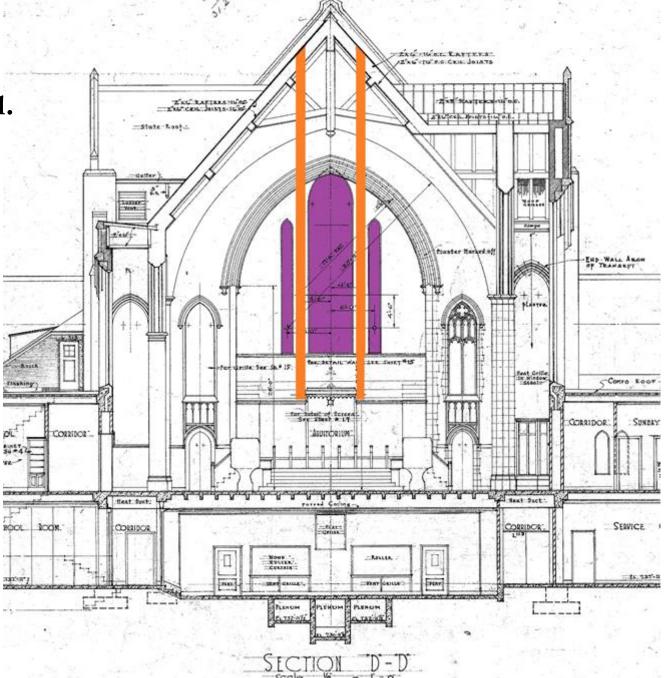
Green lines indicate location of divisions for the framework

The design for strengthening the wall.

Each pier (in orange) would get four steel rods, running vertically through the wall, and set with mortar.

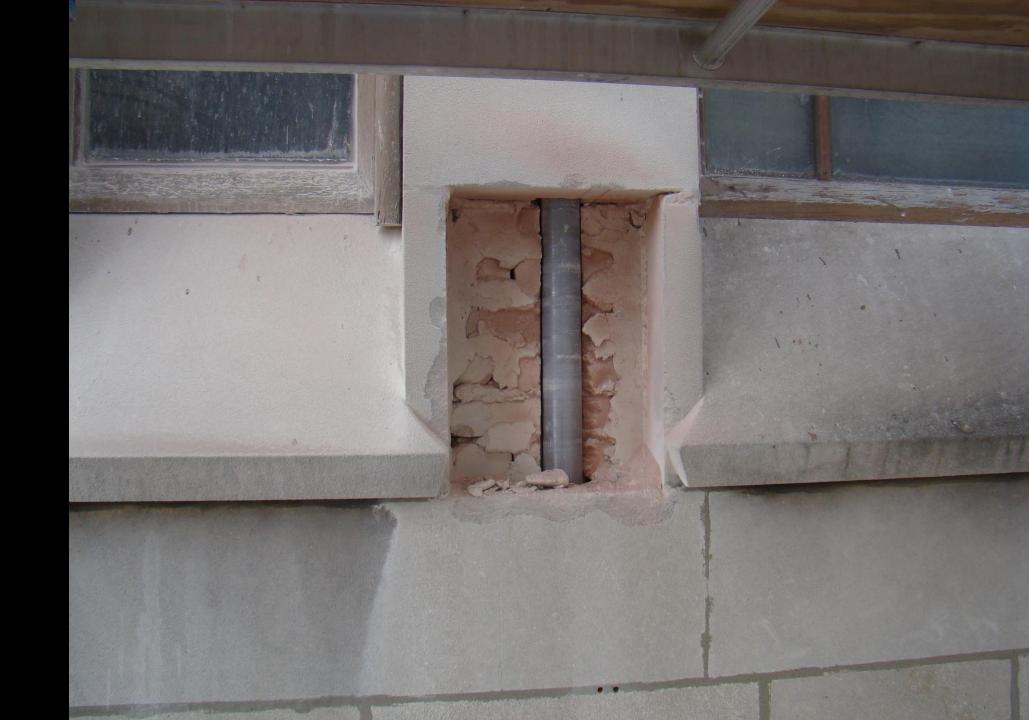
A stone pops out of the wall.

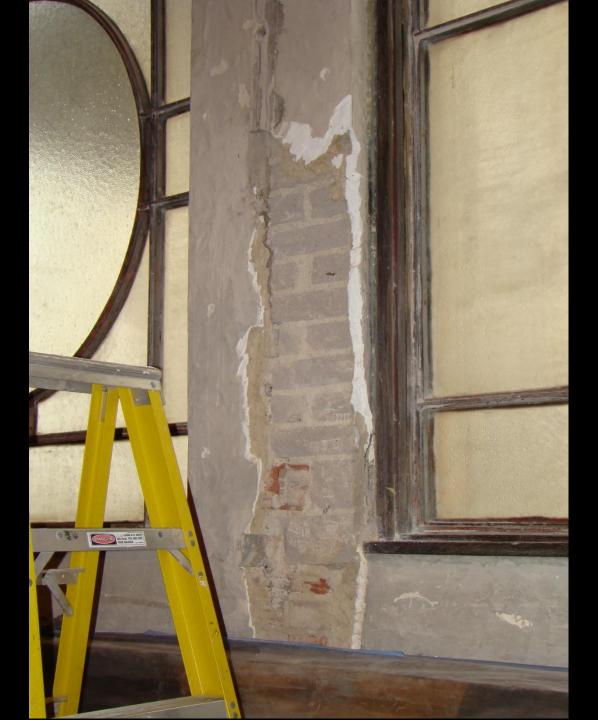
Now, to clean up that crack in the wall.

A new coat of plaster over a layer of wire mesh, across the entire wall.
