THE WALL

THE WINDOW

Te Deum Window Update

STAINED GLASS WINDOW CONDITION ANALYSIS: *Te Deum* Window by Tiffany Studios Westminster Presbyterian Church Dayton, OH

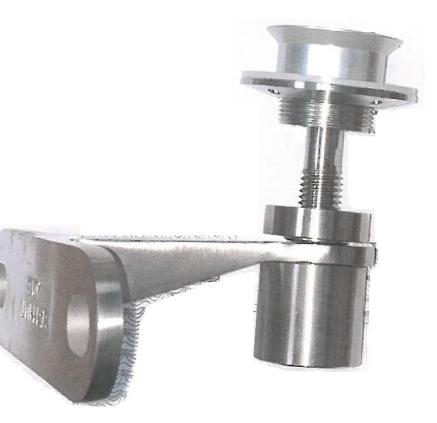
The first proposal about how to add space between the stained glass window and the exterior window.

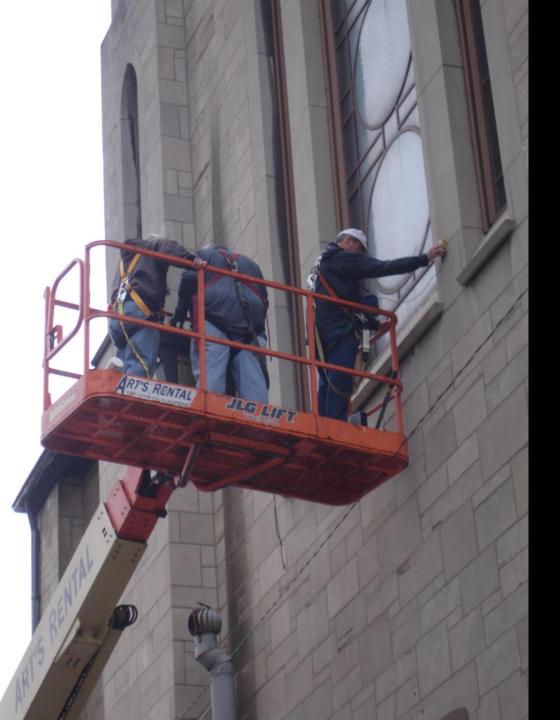
April 17, 2015 Wall evaluation

We learned the wall is full of sand-lime bricks.

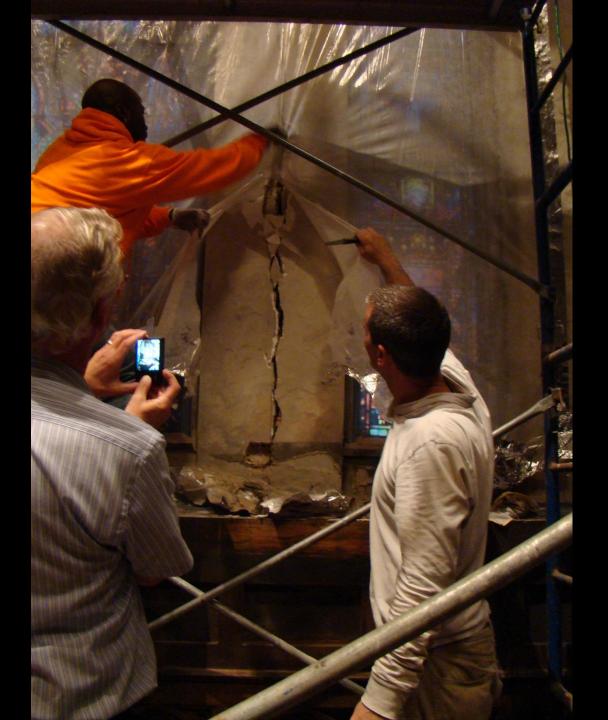
October 1, 2015

The wall splits open.

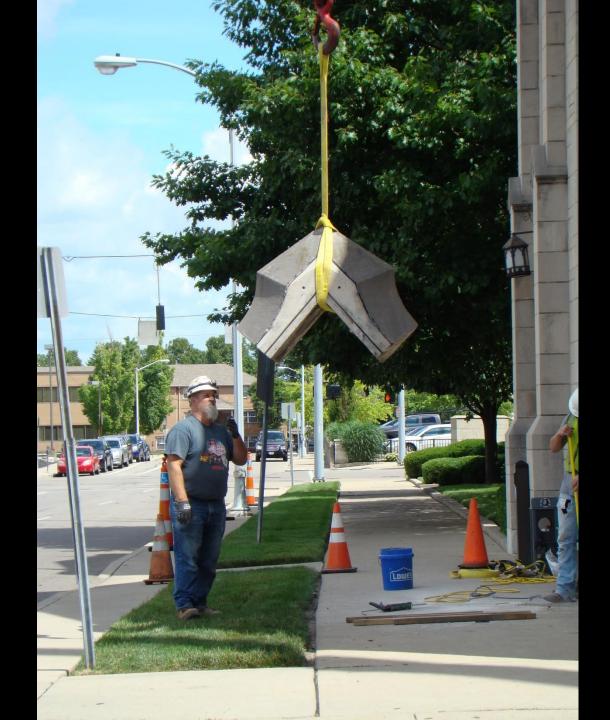
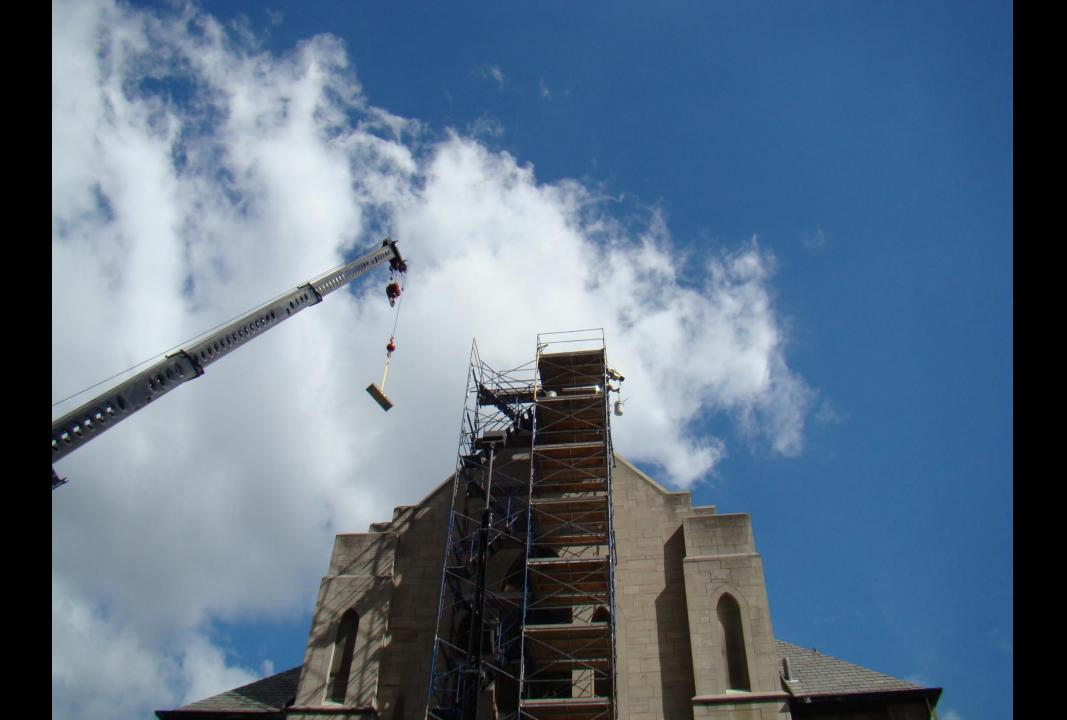
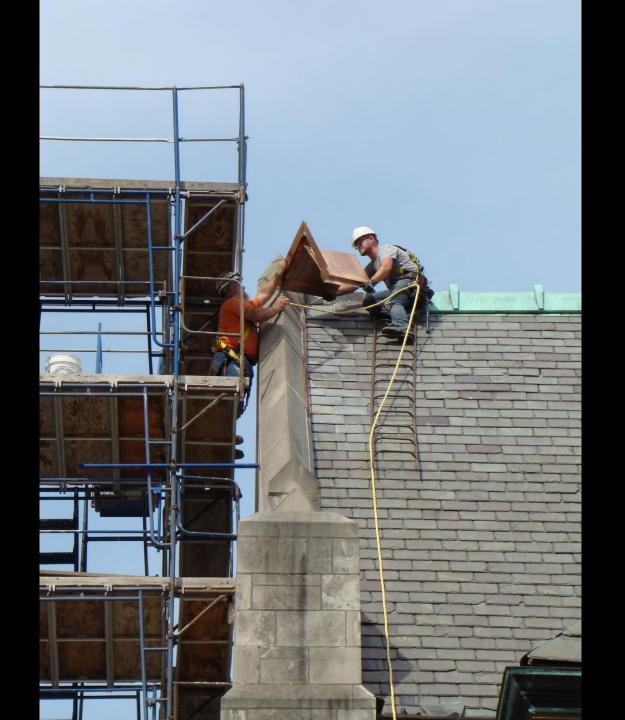
Now, to clean up that crack in the wall.
